City of Brisbane

Agenda Report

SUBJECT: Supplemental Appropriation for Ice House Hill Rock Slope Mitigation

SUBJECT: **Engineering Geologic Reconnaissance, Mapping and Evaluation**
RE: **Ice House Hill Rock Slope**
Bayshore Boulevard at Guadalupe Canyon Parkway

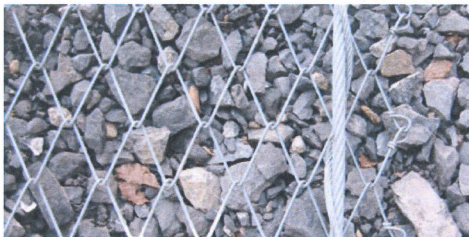
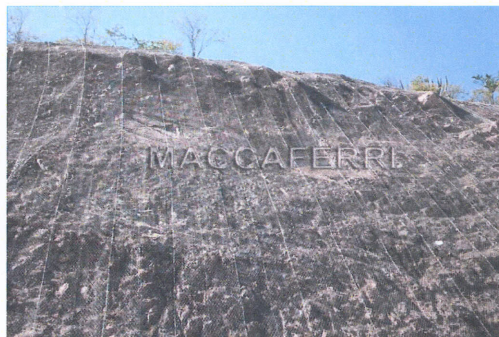
The photo on the right is an example of this material installed. The photo on the left is a close-up of the mesh.

This alternative involves removing loose rocks from the slope, clearing debris from behind the k-rail, and placing a wire mesh flat on the slope. This alternative has a low aesthetic impact, and may allow vegetation to take root under the mesh. The existing k-rail can be retained or removed.

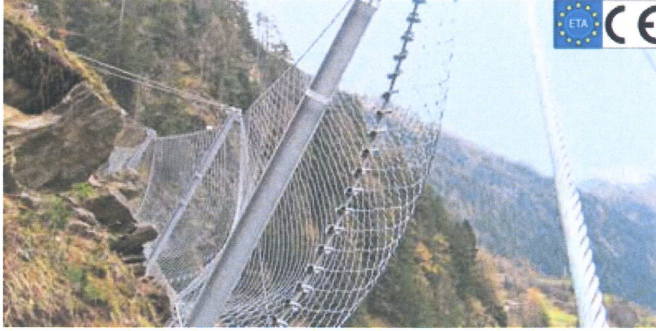
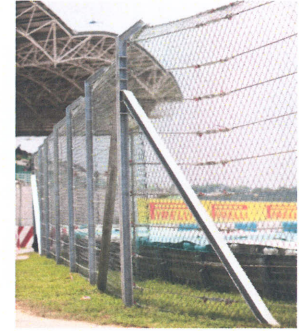
The photo on the left below shows this style of fence installed mid-slope. The photo on the right shows this style of fence installed as a protective barrier at an automobile racing venue.

This alternative involves removing loose rocks from the slope, clearing debris from behind the k-rail, and installing an approximately 8-foot high vertical catchment fence engineered to absorb the impact of bouncing rocks. This alternative has higher aesthetic impact, and requires the k-rail to remain in place.

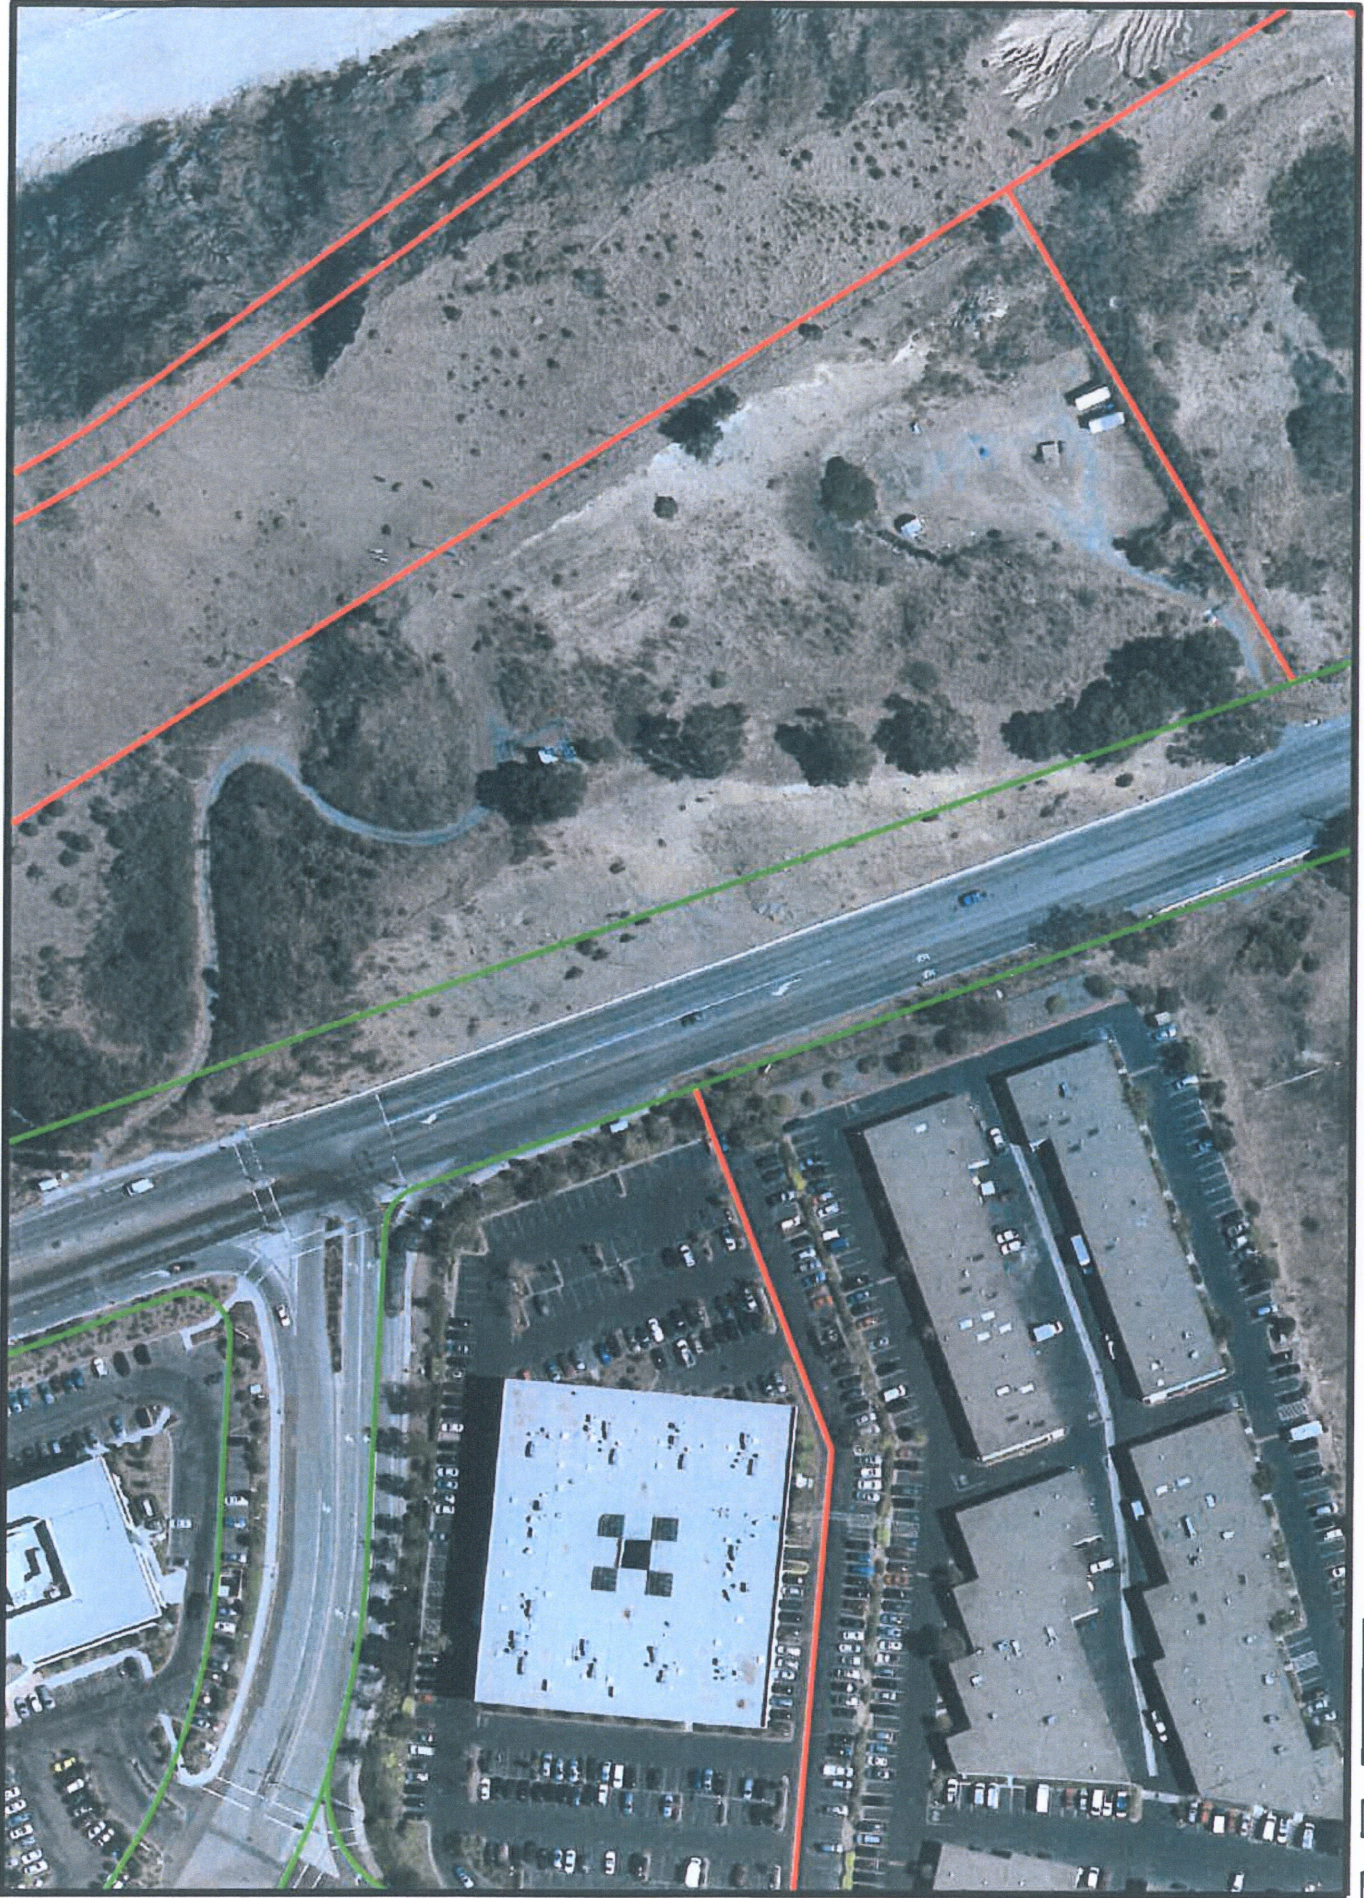
Bayshore Boulevard ROW at Ice House Hill

The right-of-way between city property and the adjoining property owner (UPC) does run through this slope. At a minimum, the city will need permission from the adjoining neighbor to access the upper portion of the slope for the proposed mitigation. As the design progresses, we will learn the actual extent of the slope that is on private property, and staff will be able to
