BRISBANE BAYLANDS HABITAT ASSESSMENT

**Sunquest Properties, Inc.
San Mateo County, California**

July 2003

**Burns & McDonnell Engineering Company, Inc.
Kansas City, Missouri**

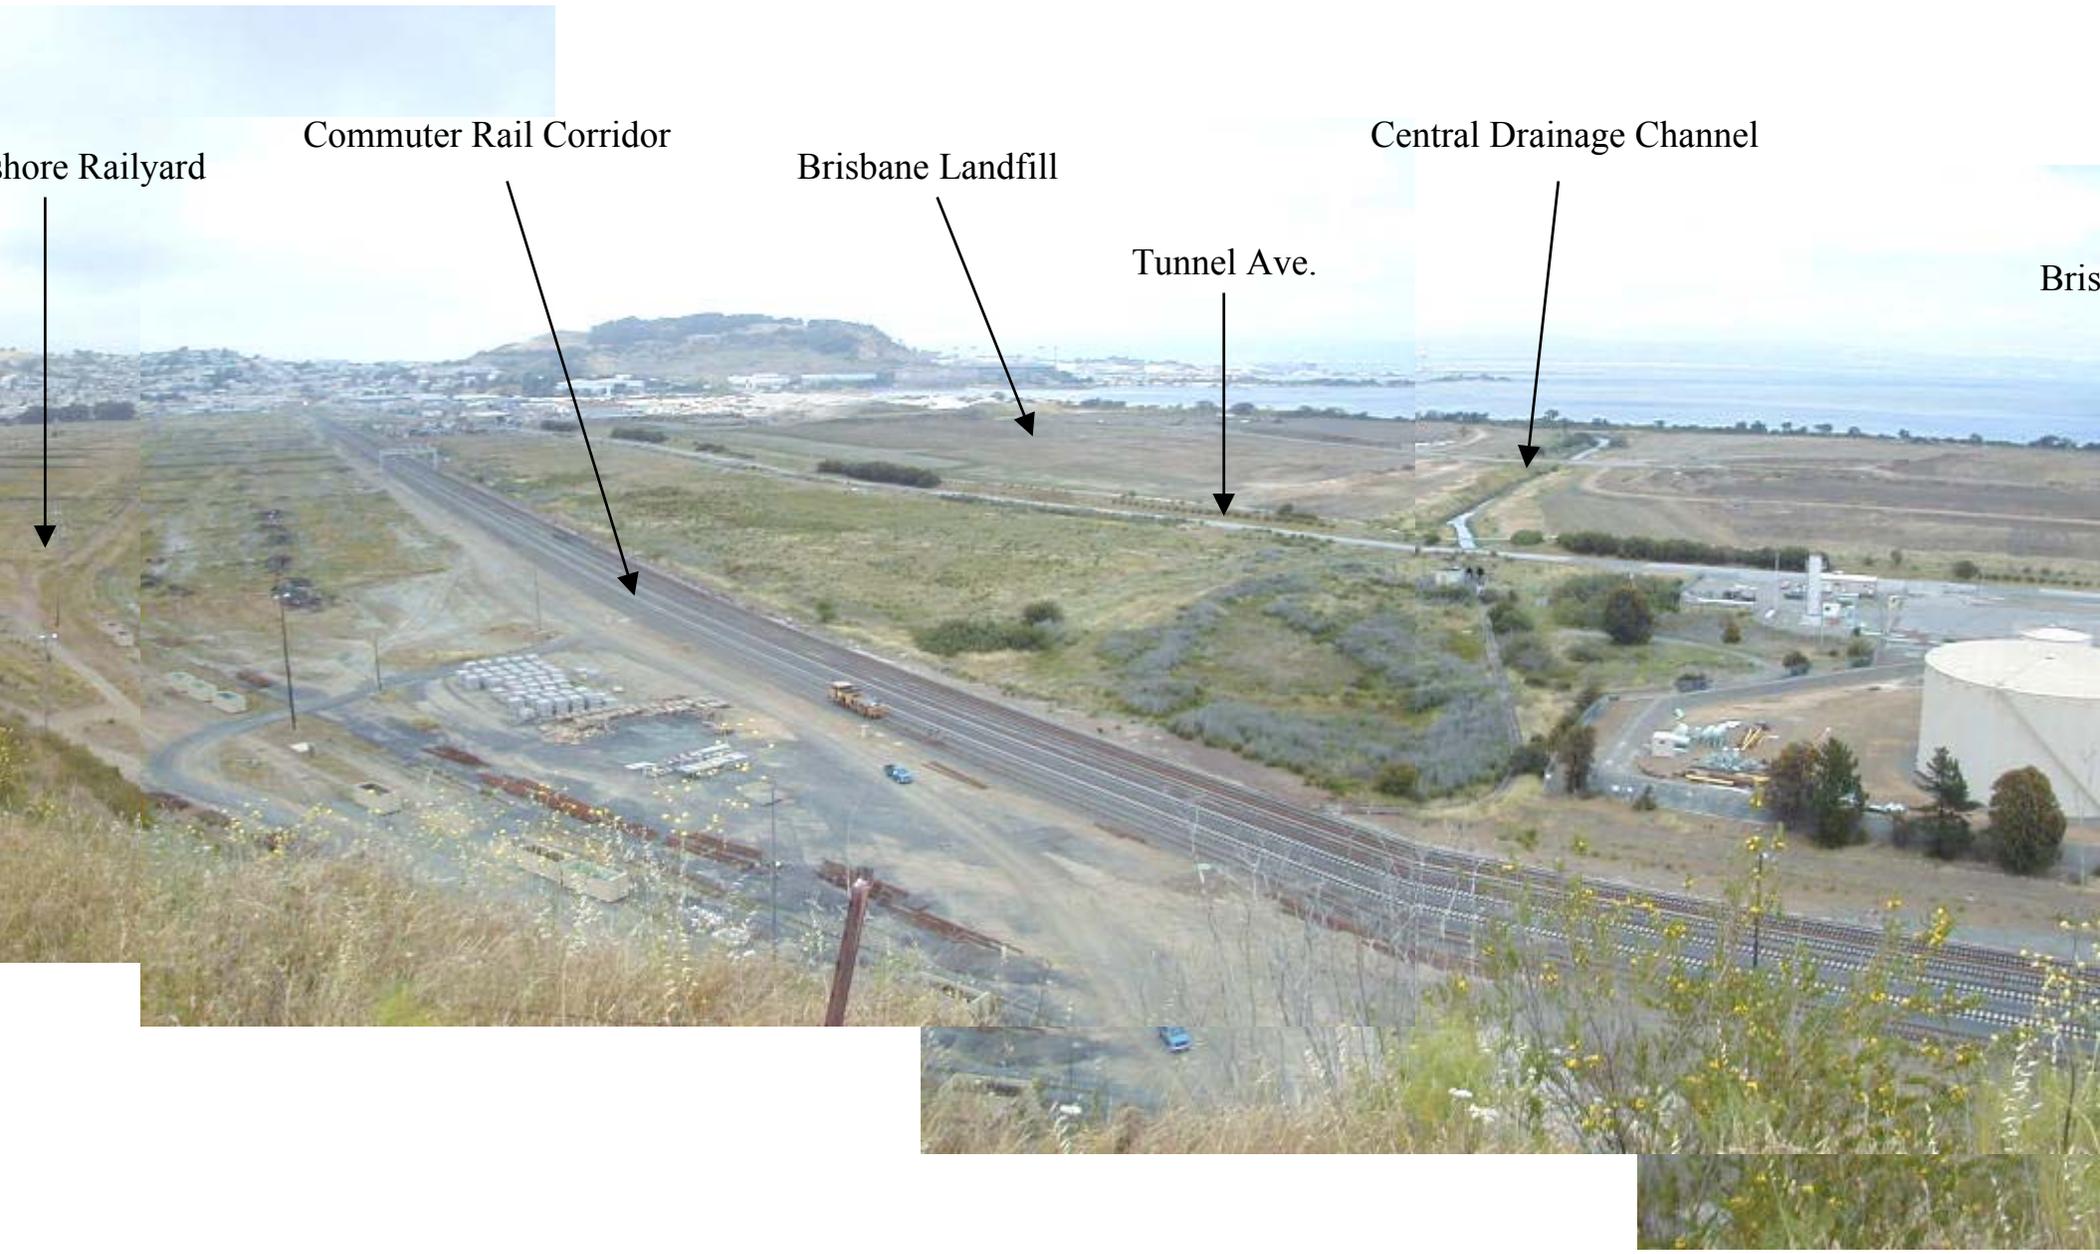
Photo 1: North and east view of Sunquest Site. Photo taken from Visitacion Point.

In May of 2003, a biologist and a wetlands scientist from Burns & McDonnell completed a habitat assessment to identify any potential protected species habitats in the Project area. Surveys were conducted at the 540-acre Project area on May 27 to 30, 2003. The site was traversed on foot to evaluate the suitability and condition of habitats for protected species. The property is located primarily within San Mateo County, but a portion to the north is located in San Francisco County. The property covers approximately 500 acres of land, of which 180 acres is within the railyard and 320 acres is within the landfill (Photos 1 and 2 in Appendix B).

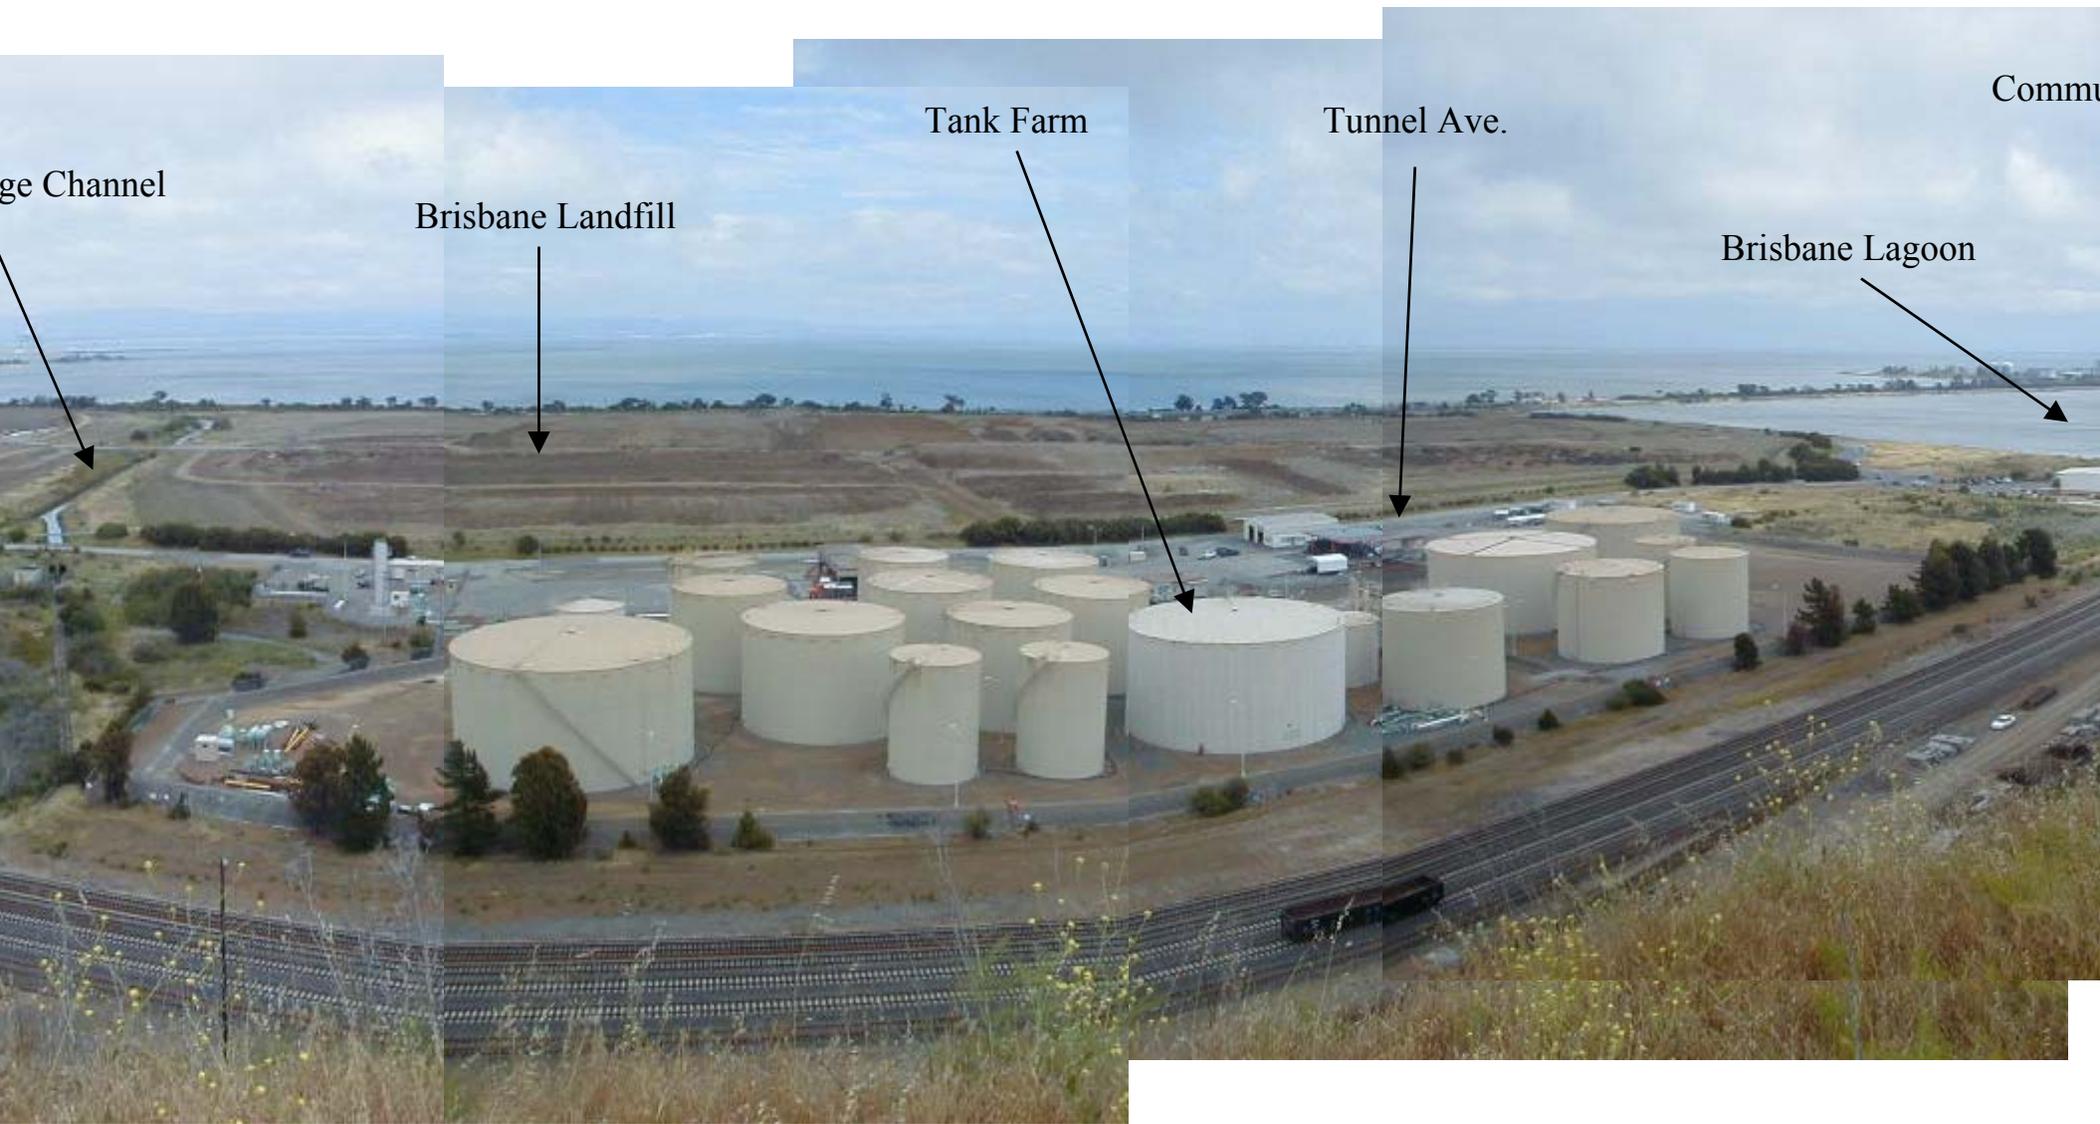
Photo 2: East and southeast view of Sunquest Site. Photo taken from Visitation Point

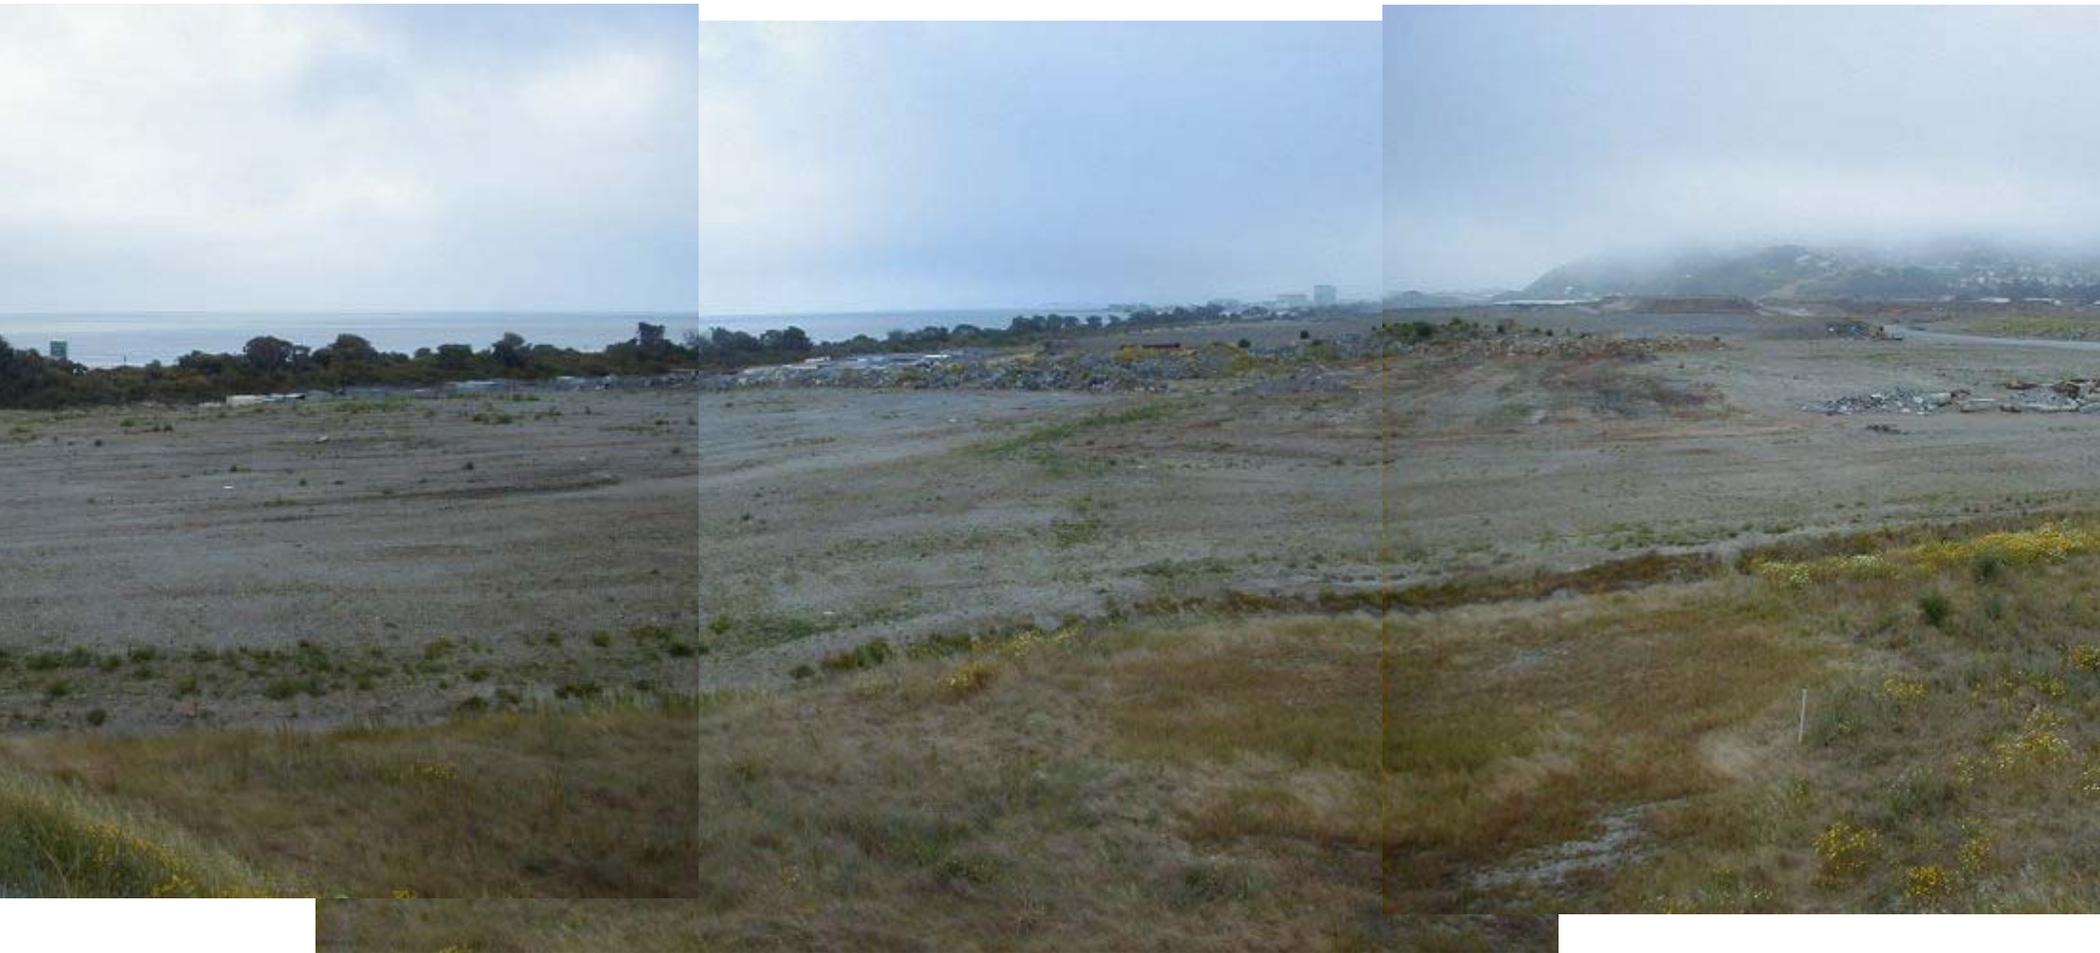
The landfill and former railyard are primarily bare ground and ruderal grassland habitat composed of non-native grasses and forbs. The majority of the surface of the landfill, which is being capped and graded, is bare dirt (Photos 3 and 4 in Appendix B). Construction debris, consisting of concrete rubble and fill dirt, is stored in piles at various locations on the landfill. Gravel and dirt haul roads cross the landfill providing trucks access to construction debris piles. The railyard has generally flat topography and is covered with ballast material and ruderal grassland habitat (Photos 5 and 6 in Appendix B). Visitacion Point, which reaches a height of approximately 200 feet above mean sea level (amsl), is located in the southwest corner of the Project site. Abandoned asphalt and concrete roadways (oriented north-south), buildings (roundhouse), and several loading ramps are all present in the western portion of the railyard. The surface of the railyard has been regularly bladed to remove dead and dried vegetation as fire control. As a result, four- to six-foot high piles of soil and ballast material (oriented east-west) cross the railyard (Photo1). Light industrial business and warehouse facilities are present along the west edge of the railyard along Bayside Boulevard and along Tunnel Avenue at the north and south ends of the landfill. The following sections briefly describe the natural resources at the site.

Photo 3: East and southeast view of Brisbane Landfill. Photo taken from the middle of the Brisbane Landfill.

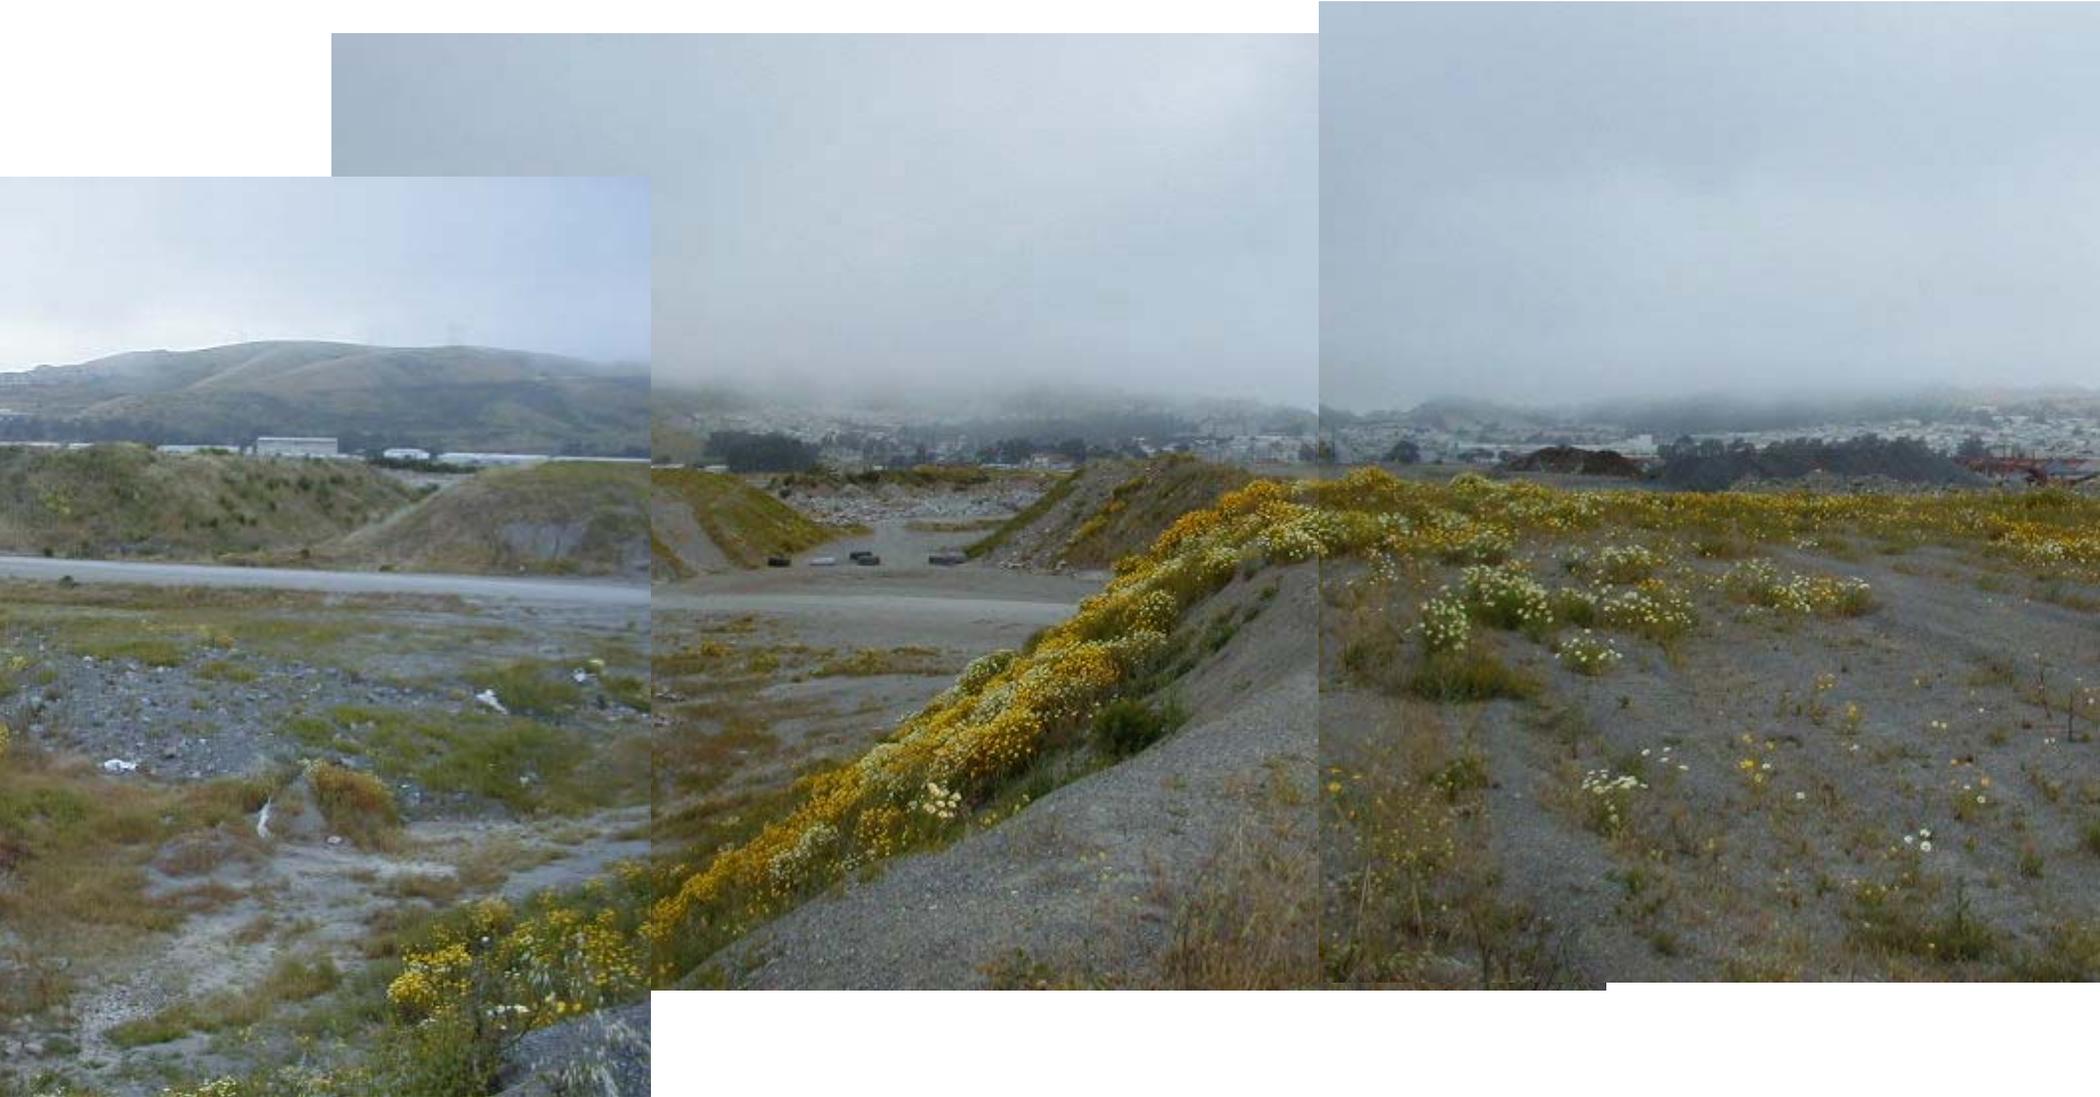
Photo 4: West and northwest view of Brisbane Landfill. Photo taken from the north end of the Brisbane Landfill.

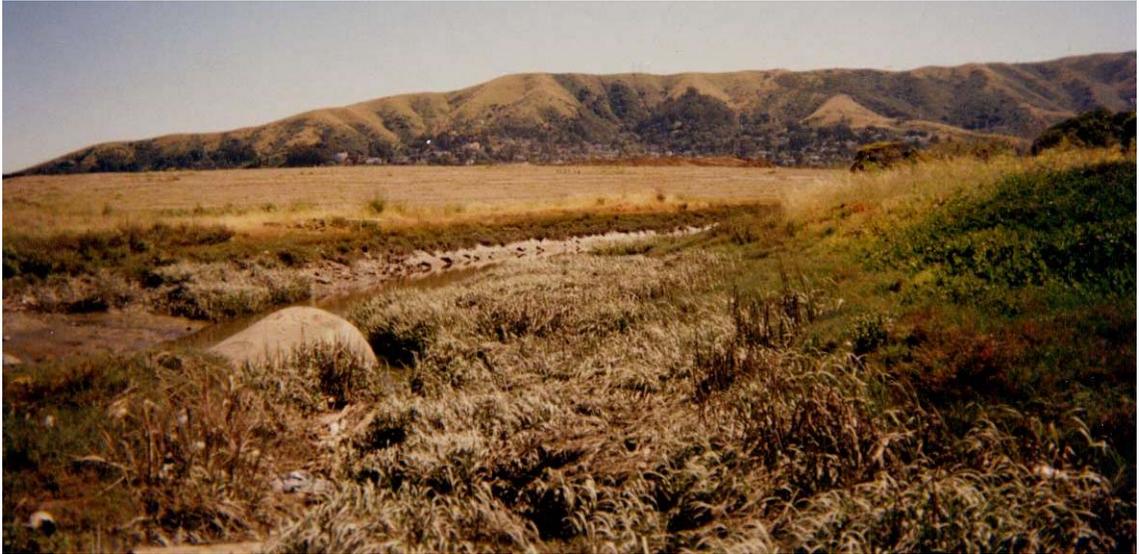
Photo 7: Looking west along the Central Drainage Channel. Photo taken from the east edge of the landfill.

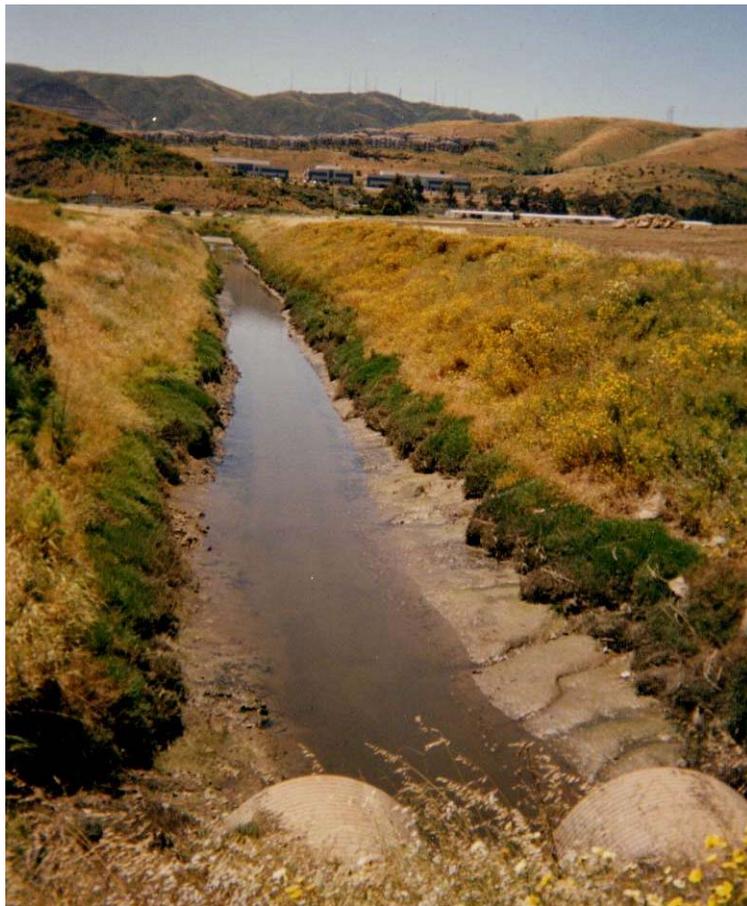
Photo 8: Looking west along the Central Drainage Channel. Photo taken from the middle of the landfill at a haul road crossing.

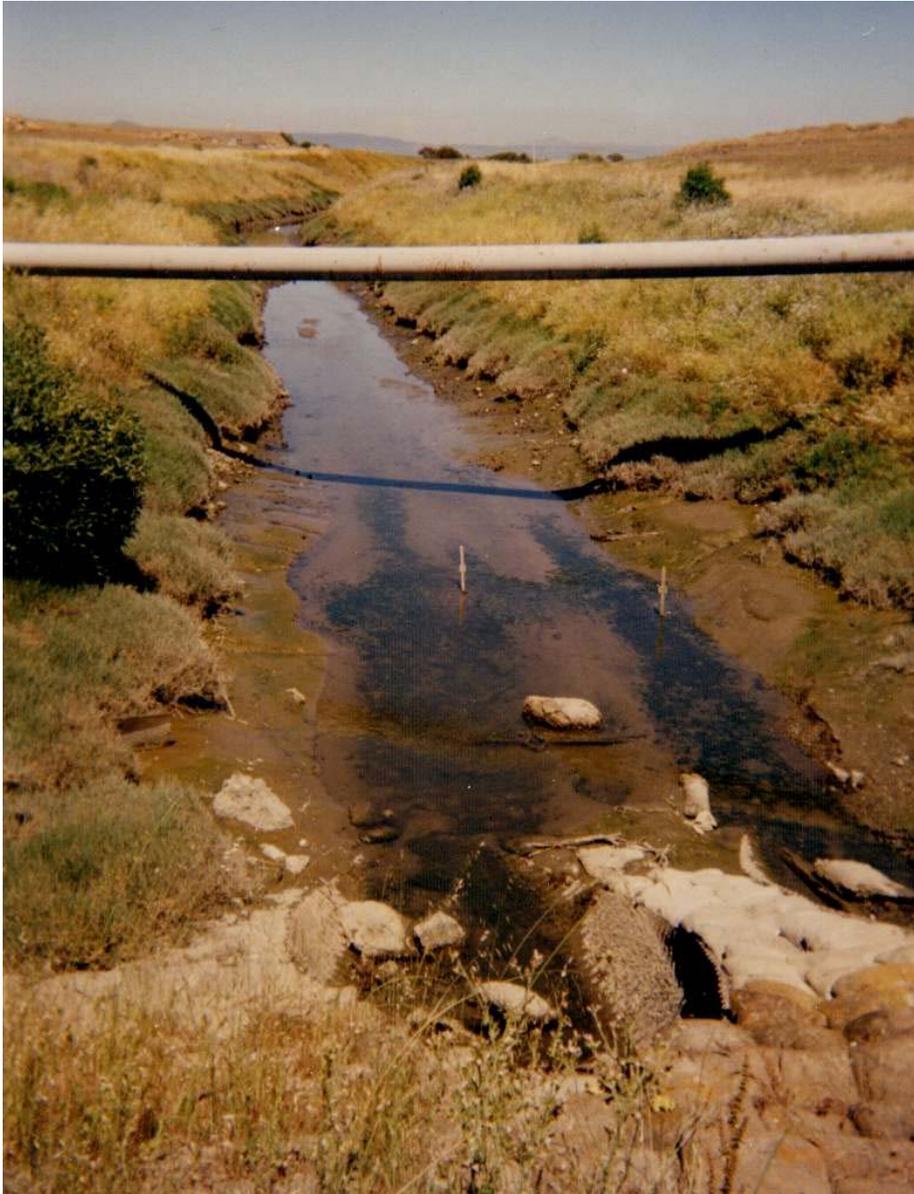
Photo 9: Looking east along the Central Drainage Channel. Photo taken from the Tunnel Avenue road crossing.

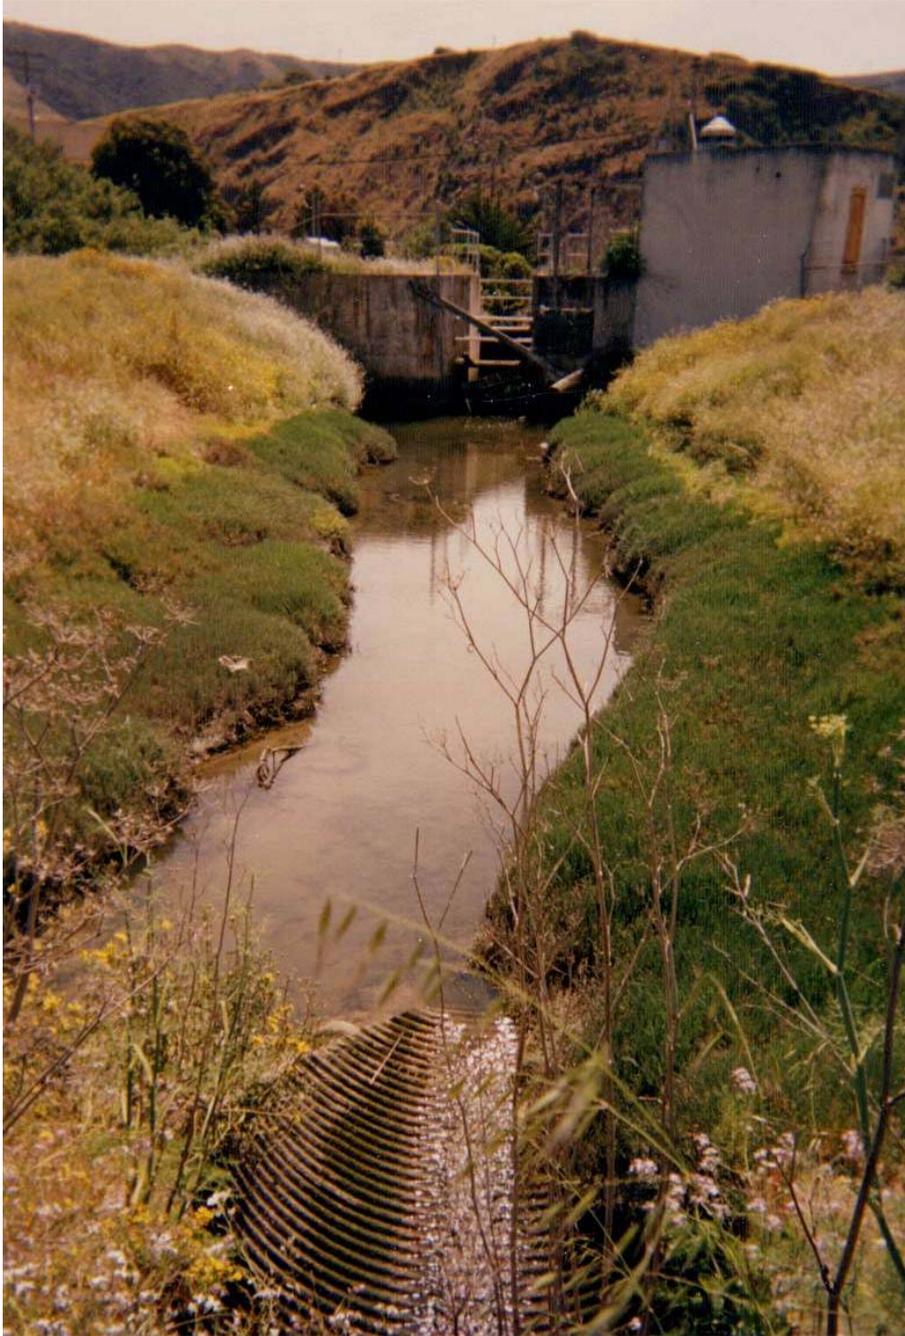
Photo 10: Looking west along the Central Drainage Channel. Photo taken from the Tunnel Avenue road crossing.

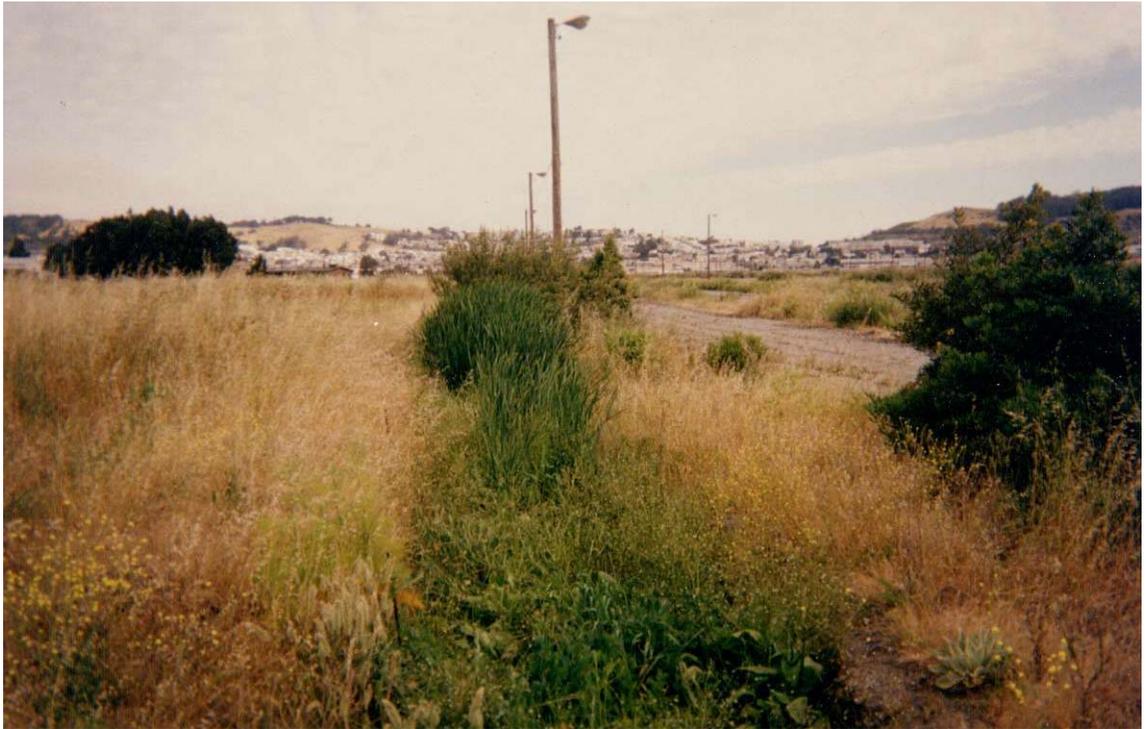
Of the two ditches located in the railyard, the east-west ditch is seven to nine feet wide and 770 feet long (Photo 11 in Appendix B). The north-south ditch and swale is 10 to 12 feet wide by 1,240 feet long (Photos 12 in Appendix B). Both the ditches are dominated by emergent wetland vegetation including tall flatsedge, robust bulrush, cattails, common spikerush, bent grass, brass-buttons, and common threesquare bulrush. The ditches were inundated with water, presumably from runoff. The east-west ditch drains into the north-south ditch, which eventually empties into the central drainage channel through a timber box culvert (Photo 13 in Appendix B). When the railyard was still in service, the north-south ditch was used to separate oil from water runoff. An oil water separator structure is still located half way up the ditch. The surface of standing water along this ditch still exhibits an oily sheen.

Photo 11: Looking northeast along the east-west drainage ditch in the railyard.

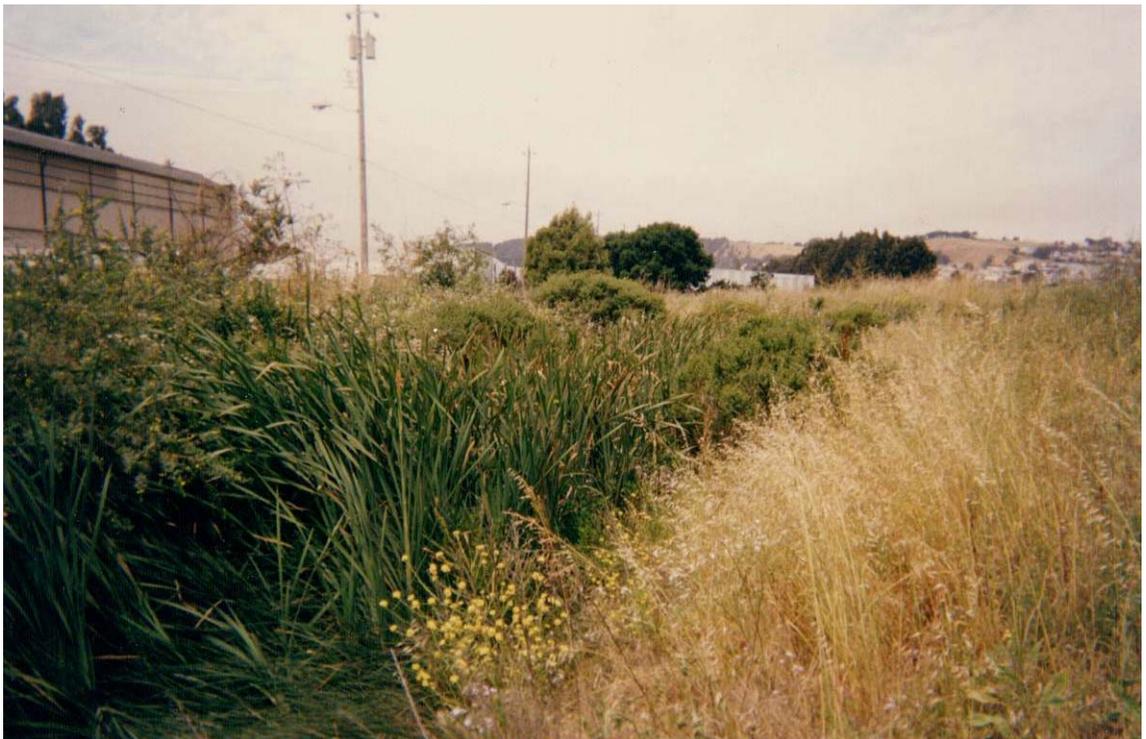
Photo 12: Looking north along the north-south drainage ditch on the western edge of the railyard.

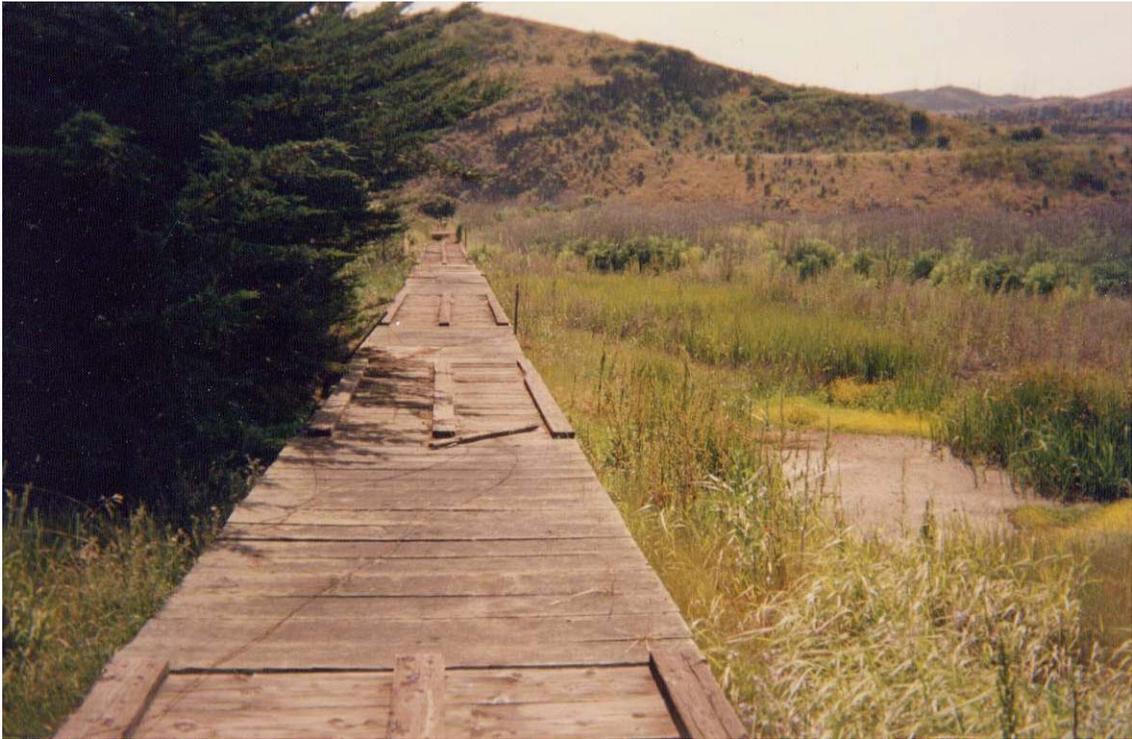
Photo 13: Looking west along the timber box culvert that is west of the Central Drainage Channel west of the Tunnel Avenue road crossing.

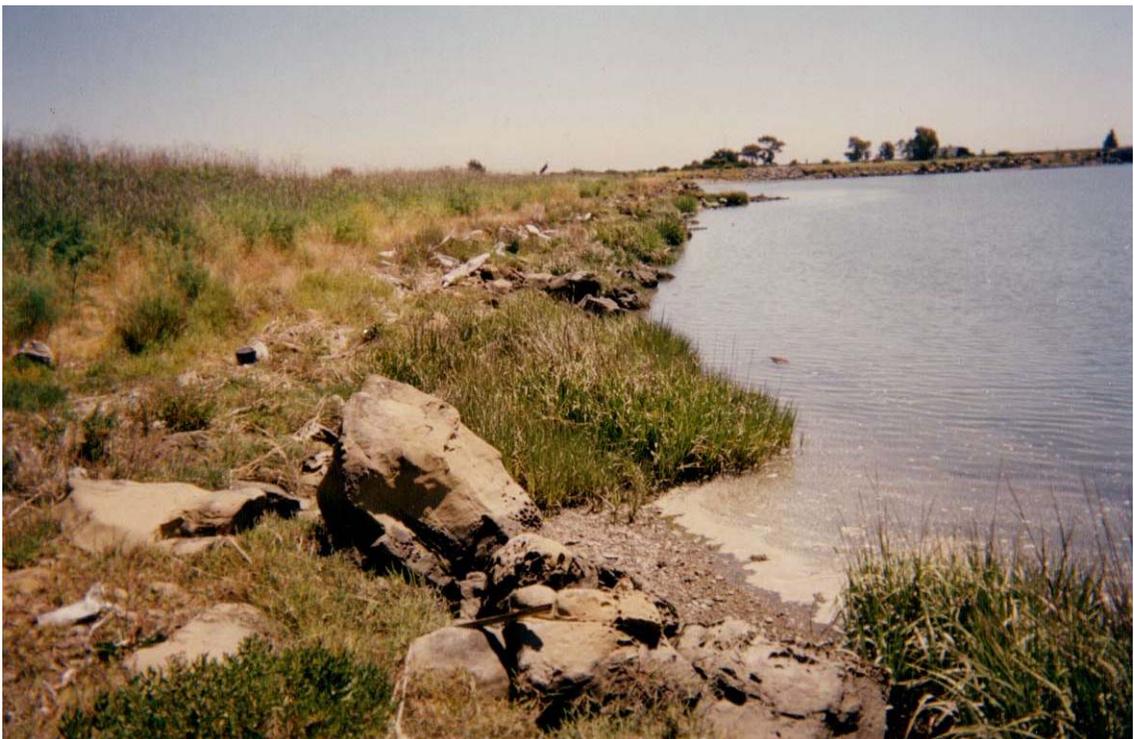
The Brisbane Lagoon, which has a regularly flooded, intertidal estuarine, unconsolidated shoreline (E2USN), is tidally influenced. The shore is lined with small boulders and dominated by European beach grass (Photo 14 in Appendix B). Trash is present among the boulders and the shoreline appeared to be used by local, recreational fisherman.

Photo 14: Looking east along the shore of the Brisbane Lagoon at the south end of the project area.

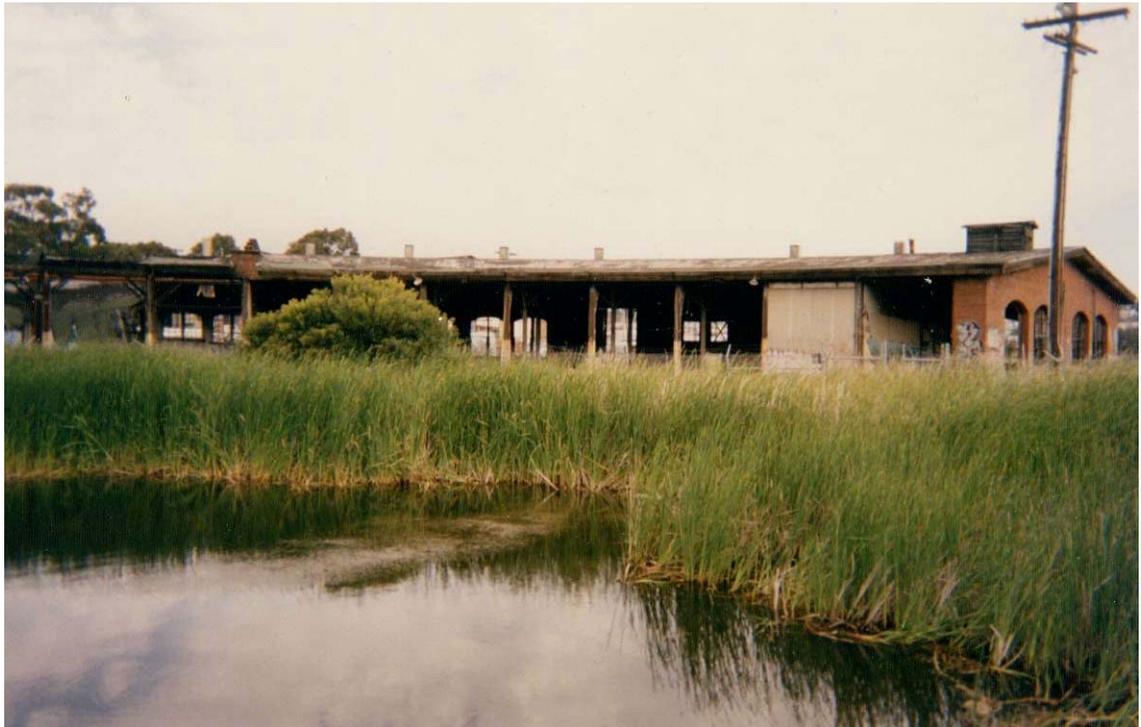
An open water wetland has formed in the concrete lined depression for the railyard's roundhouse turntable. The concrete lined depression has vertical walls, is encircled by a chainlink fence, and is inundated with water and colonized by broad-leaved cattails (Photo 15 in Appendix B). The surface of the water is approximately one to two feet below the top of the concrete lined depression. No wildlife was observed in the concrete lined depression.

Photo 15: The open water wetland that formed in the concrete lined depression for the turntable at the railyard's roundhouse.

The proposed preliminary development plan for the Project site (Figure 2 in Appendix A) will require the relocation of the two ditches in the railyard, filling the open water wetland in the vicinity of the roundhouse, removal of the timber box culvert, and a considerable amount of construction along the central drainage channel and north shore of Brisbane Lagoon. The development plan also includes the creation of parkland along the central drainage channel, north shore of the Brisbane Lagoon, and the proposed channel through the former railyard. In addition to providing aesthetic value to the development, these park areas will likely provide habitat for common wildlife and plant species and may also provide suitable habitat for protected species.

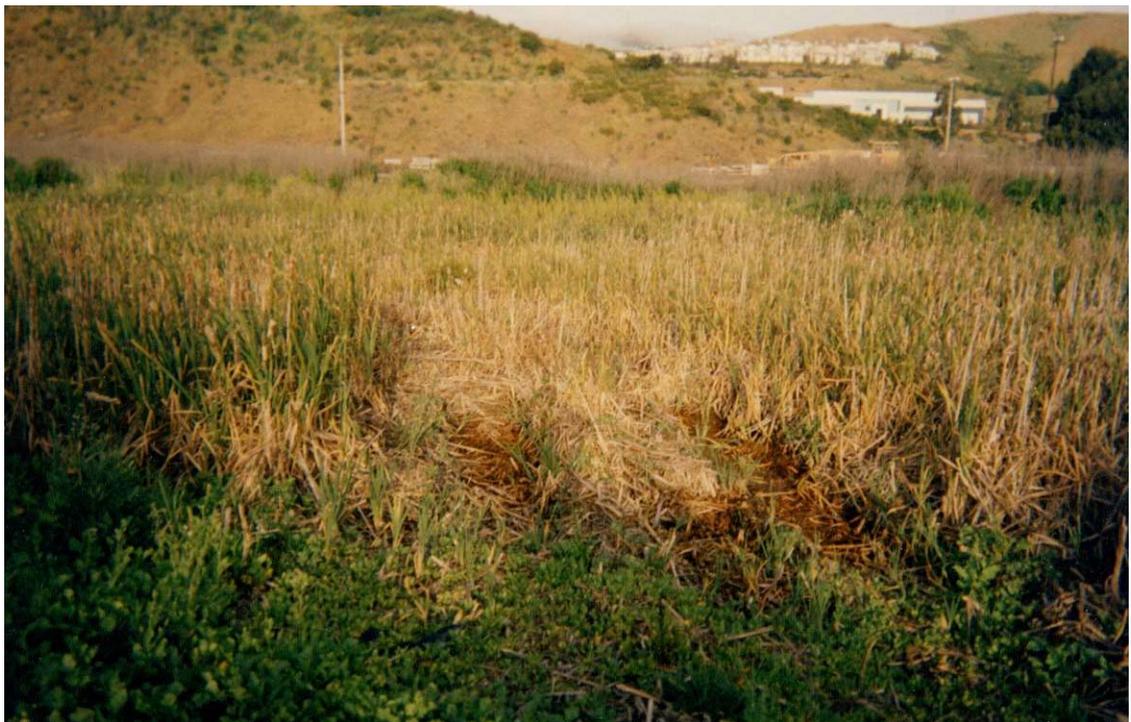
Rain runoff accumulates in manmade depressions that are in poorly drained areas at the south end of the railyard. These seasonally flooded, diked or impounded, palustrine emergent wetlands (PEMCh) at the south end of the railyard exhibited an oily sheen where water had collected in tire ruts (Photo 16 in Appendix B). These wetlands also appear to be the result of pooling water in an area that was excavated

Photo 16: Looking west at a cattail wetland north of the wooden box culvert that covers the Central Drainage Channel and west of the Tunnel Avenue road crossing.

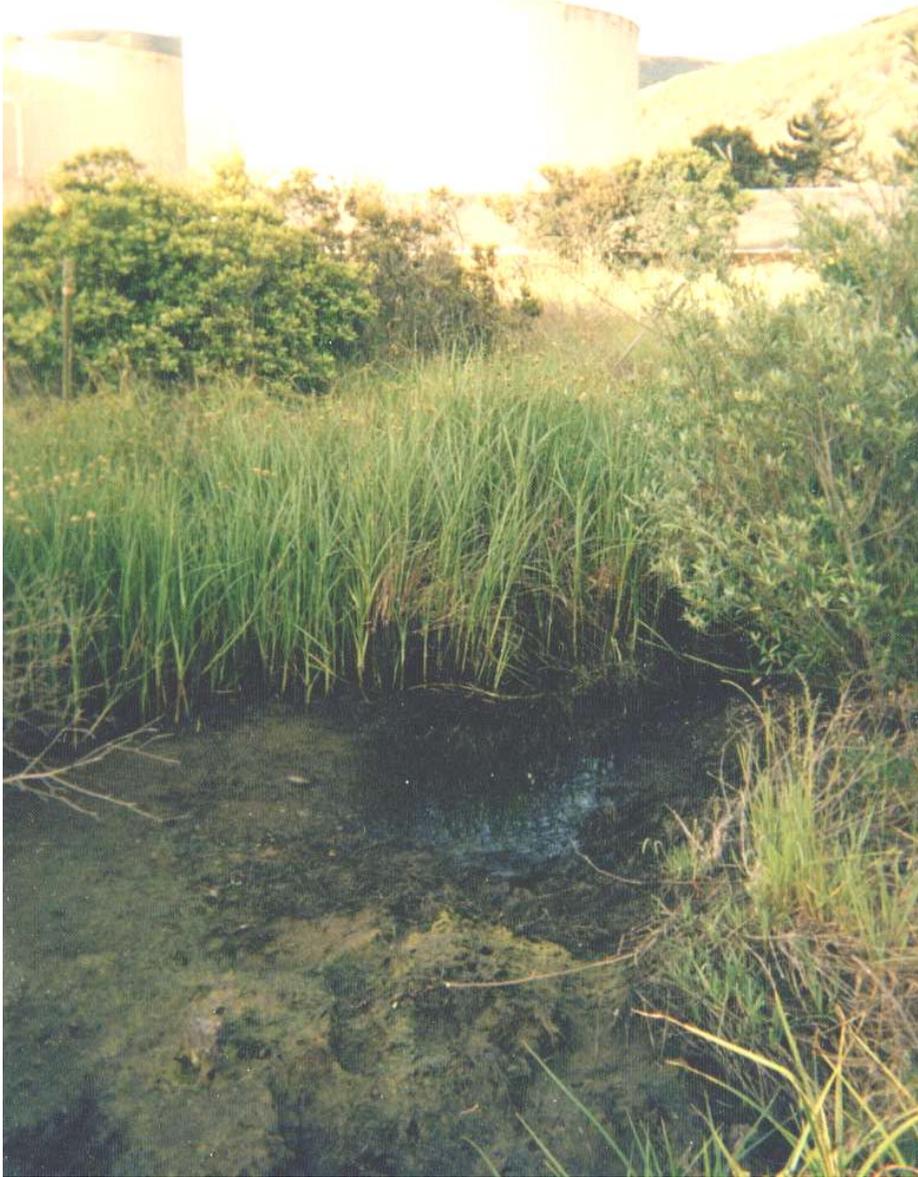
Photo 17: Small pool of water in a wetland at the southern end of the railyard that contained California toad tadpoles (*Bufo boreas halophilus*).
